Chilangoma Construction Report

18 May to 30 June, 2025

Compiled by Dezie Trigu

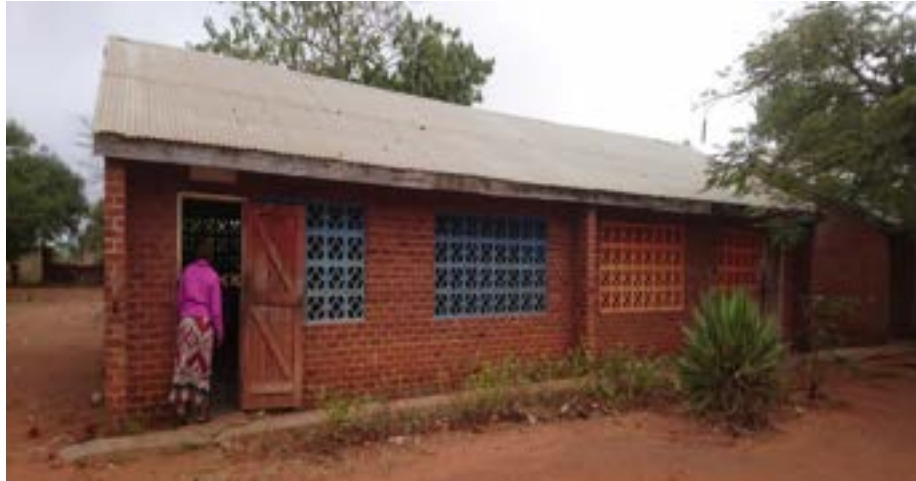
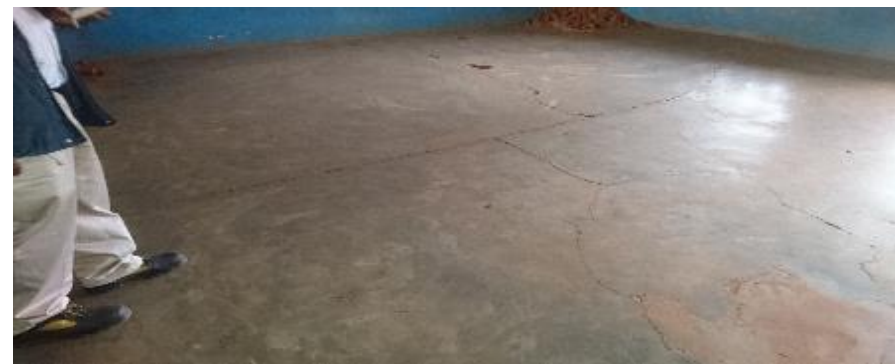
BLOCK ONE Stds 4 and 5

Block One: It has two classrooms

Block one renovation needs are:

- Floor repair
- 3 doors replacement
- 14 ring windows
- Ring beam building
- 2 notice boards replacement
- Roof sealing
- Drain building (20 X2 =40m)
- Fascia board replacement
- Side paving
- 2 ten feet sheets of 28 gauge each
- Wall repair/plaster and paint

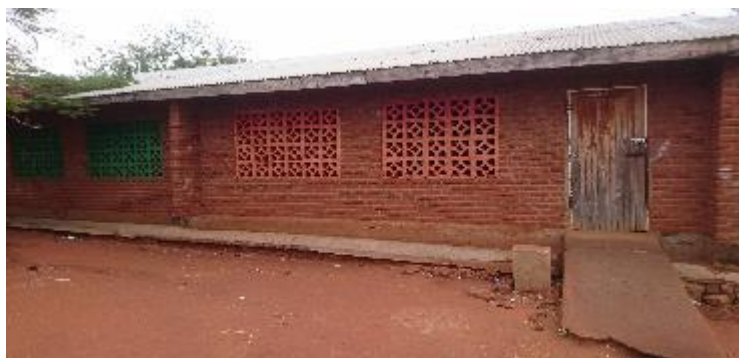
The floor

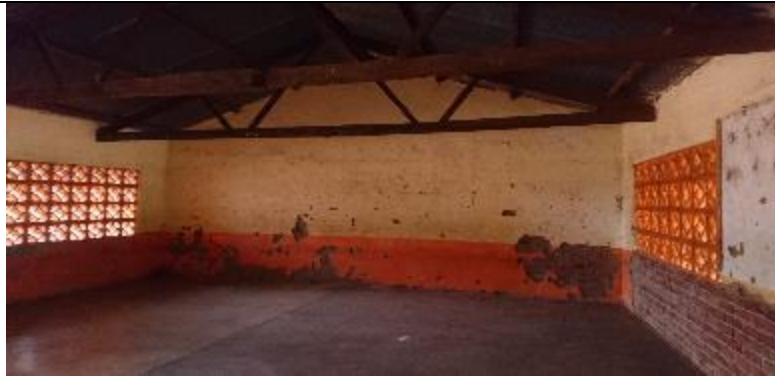
Inside Block two has standards 4 and 5

Block Two and three renovation needs are:

- Floor repair
- 3 doors replacement
- 14 ring windows
- Ring beam building
- 2 notice boards replacement
- Roof sealing

- Drain building (20X2=40m)
- Fascia board replacement
- Side paving
- 2 ten feet sheets of 28 gauge each
- Wall repair/plaster and paint

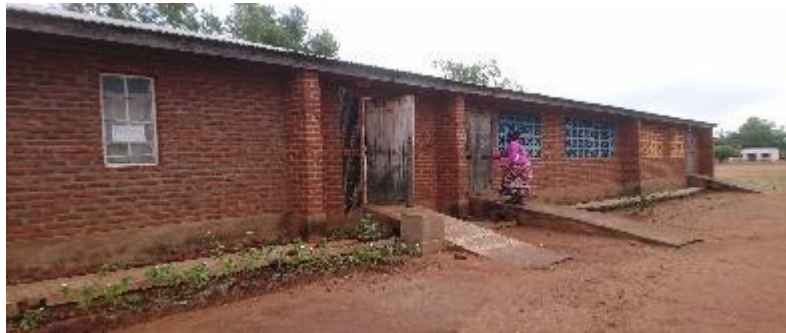
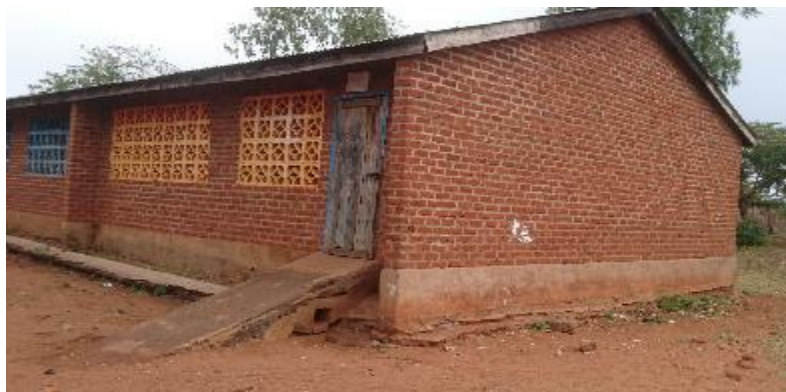
JOINED BLOCKS THREE AND FOUR: Has 4 classrooms (Std 1,2 3 and 4), headteacher's office, staffroom and library (the library only has been repaired)

Block 3 has 2 classrooms

The joined Blocks Three and Four renovation needs are:

- Floor repair
- 5 doors replacement
- 28 ring windows
- Ring beam building
- 4 notice boards replacement
- Roof sealing
- Drain building (44X2=88m)
- Fascia board replacement
- Side paving
- 2 ten feet sheets of 28 gauge each
- Wall repair/plaster and paint
- Paving both sides
- Install solar in the whole block since it is taking long for the school to be connected to the national electricity grid

NB: Meaningful Repair of this block will require the repair of all the 4 classrooms (Blocks 3 and 4) and headteacher's office

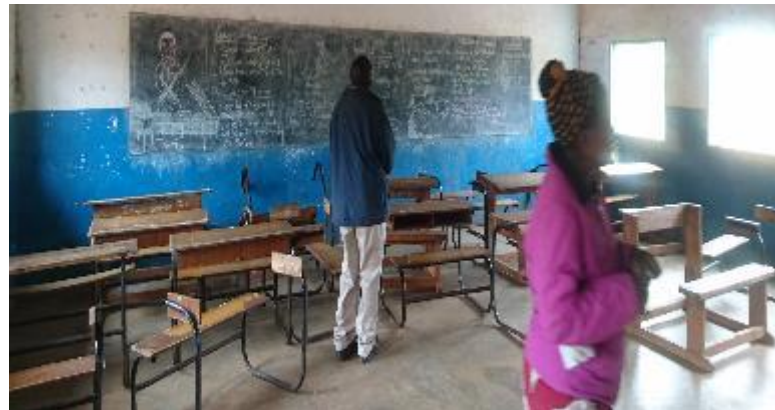
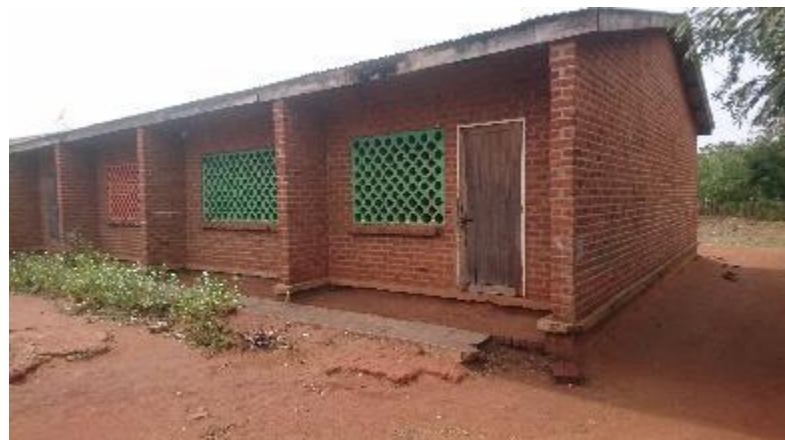
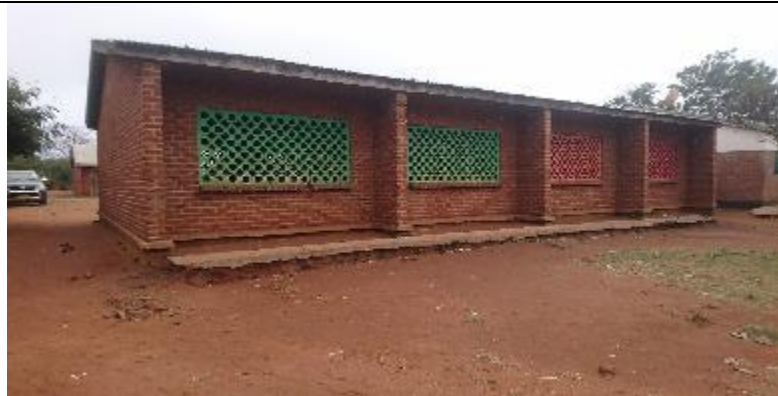
BLOCK FIVE. Standards 6 and Std1 (Already repaired in June 2023)

Inside one of block 5 classrooms

Block 5 has standards 6 and 1 (Already)

Block Five renovation needs were (Now renovated):

- Floor repair
- 4 doors replacement because of lockers
- 14 ring windows
- Ring beam building
- 2 notice boards replacement
- Roof sealing
- Drain building (22X2=44m)
- Fascia board replacement
- Side paving
- Wall repair/plaster and paint
- Paving both sides
- Repairs 2 lockers

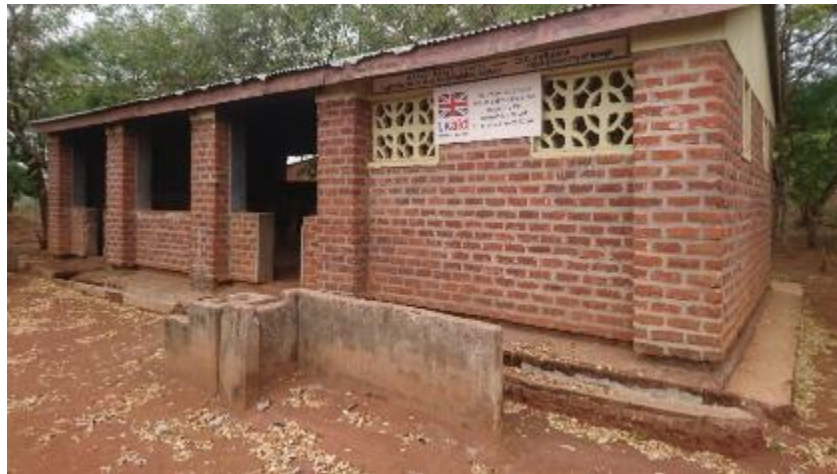
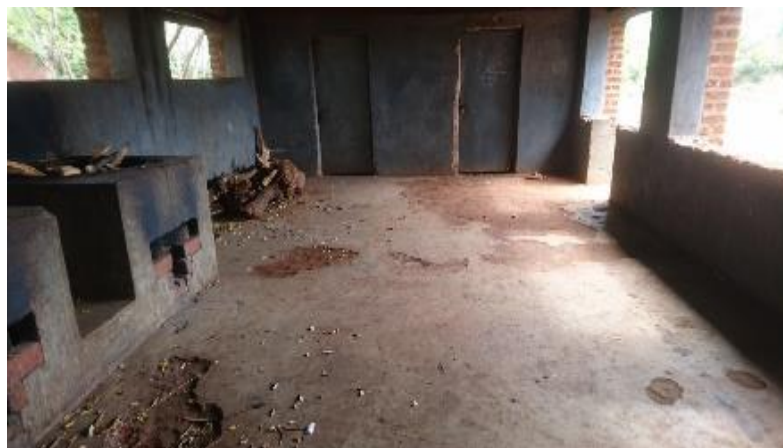
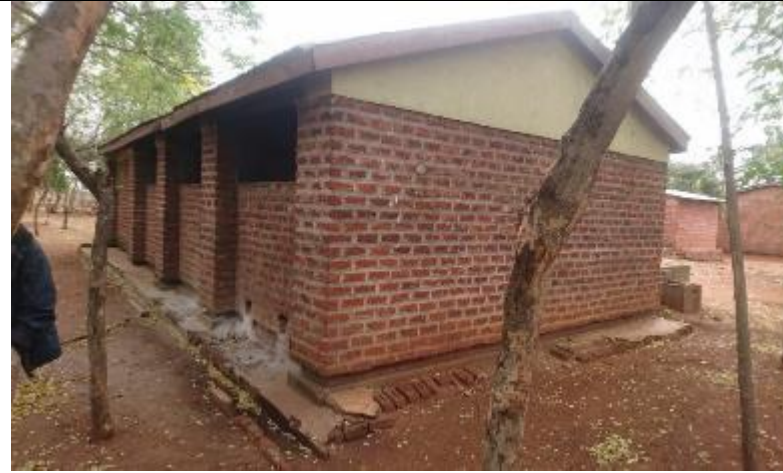
Mary's Meals Kitchen

Around the MM kitchen

Kitchen renovation

needs are:

- Floor repair
- 2 doors replacement because of lockers
- Roof mending and sealing
- Drain building
- Fascia board painting
- Side paving
- Wall repair/plaster
- Termite treatment

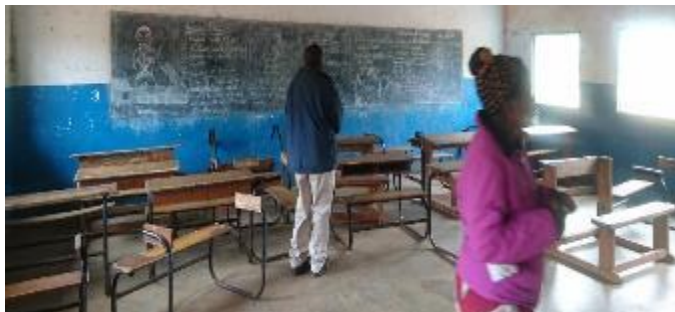
The above are the school desks that the school had during the needs assessment and most of the learners were sitting on the floor
