Chilangoma Construction Report

18 May to 30 June, 2025

Compiled by Dezie Trigu

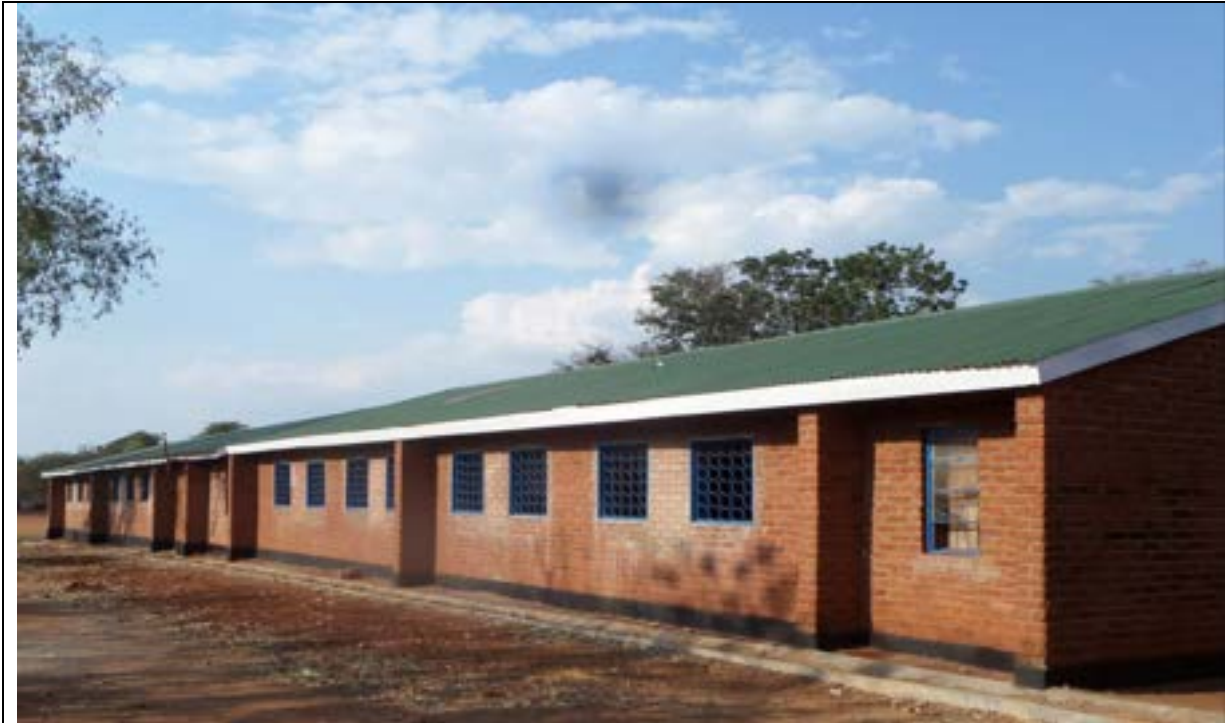
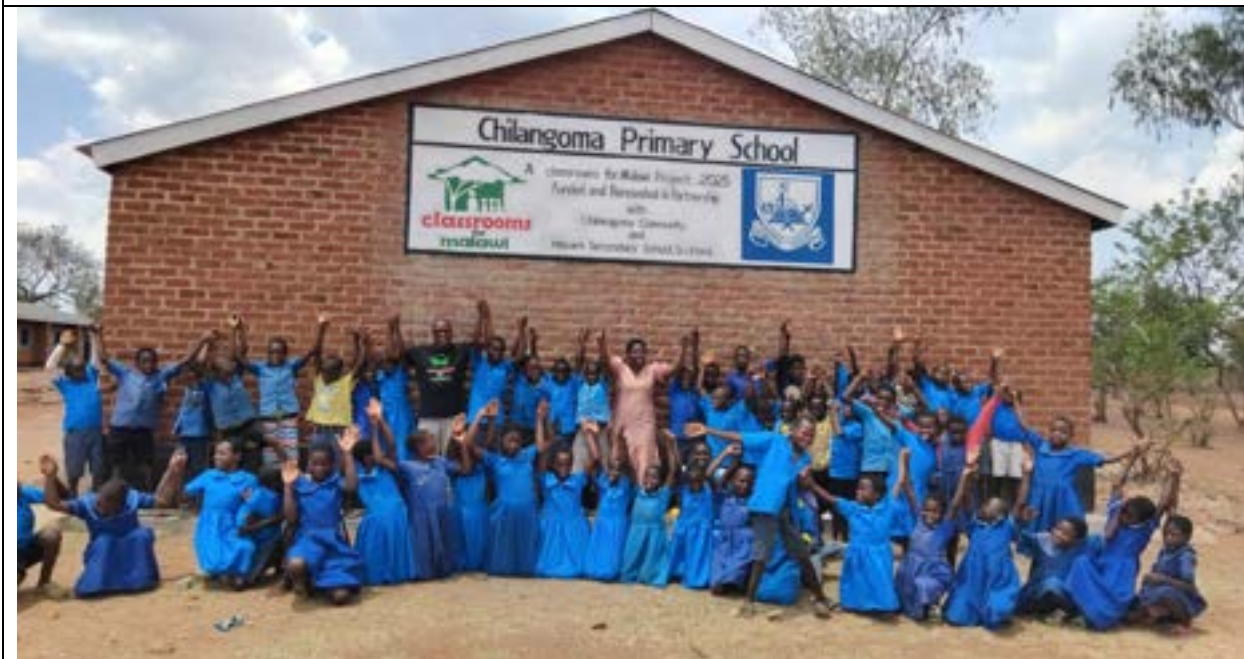
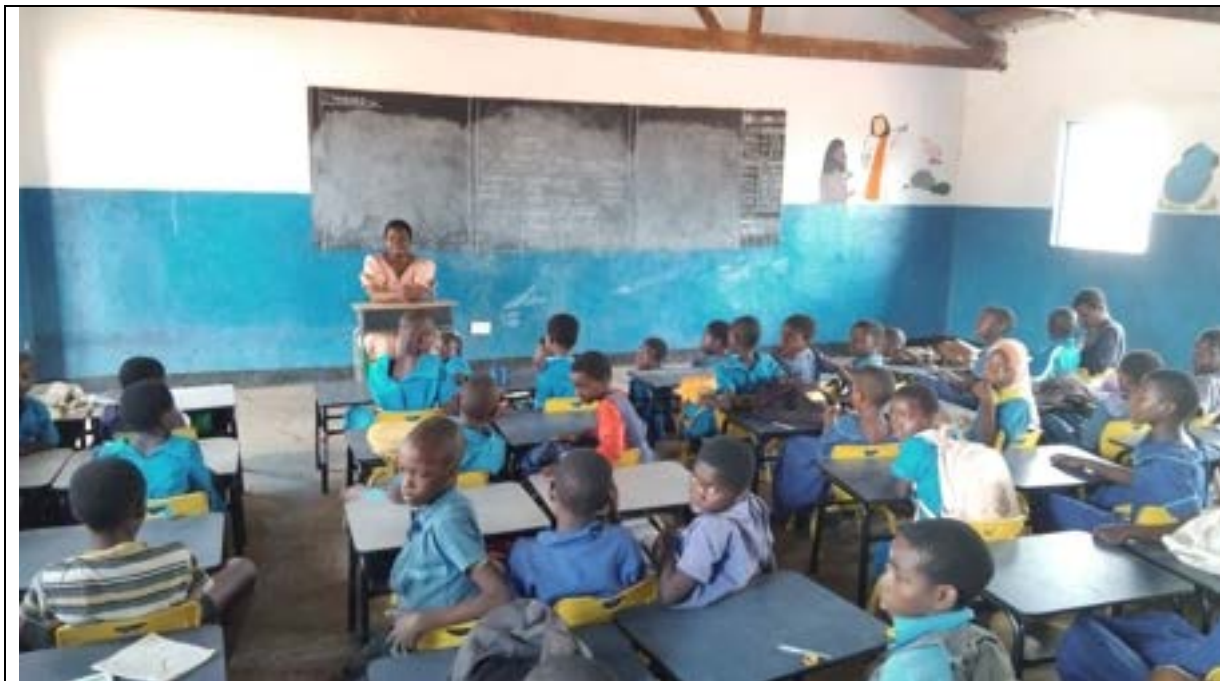
BLOCKS TWO AND THREE AFTER RENOVATIONS IN 2025

Inside one of the renovated classrooms

- Floor repair
- 5 doors replacement
- 28 ring windows were fitted;
- Ring beam building;
- 4 notice boards replacement;
- Roof sealing;
- Roof guarding;
- Drain building (44X2=88m);
- Fascia board replacement;
- Worn out 2 ten feet sheets of 28 gauge each were replaced with new ones;
- Wall repair/plaster and painting; and
- Wiring/ electrification in readiness for solar
